Exterior Stone Conservation Study

Philadelphia Merchants' Exchange

Pennsylvania Blue Project Background

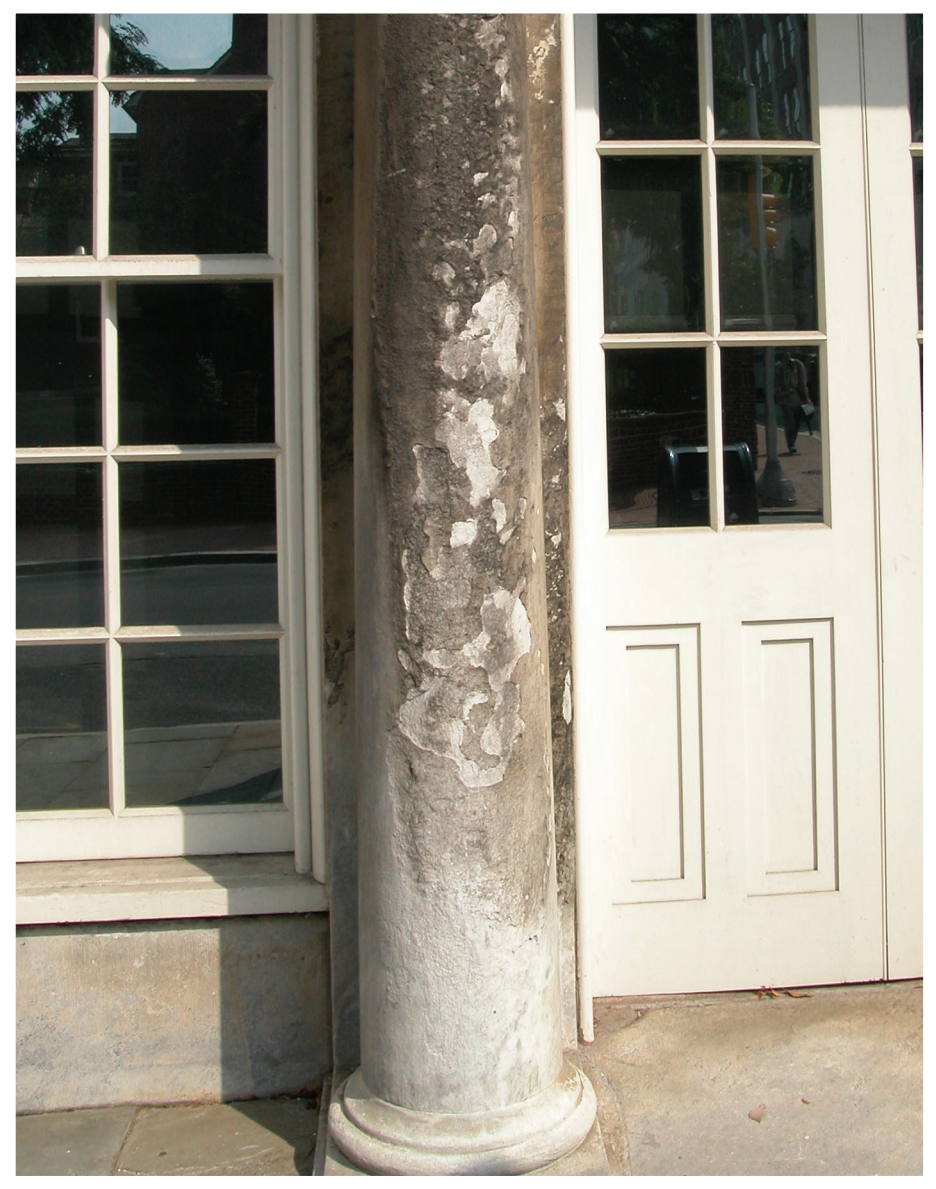
Location: West Elevation, Column Four
Source: University of Pennsylvania

There are two major deterioration mechanisms that affect the columns. 1) Black surface encrustation caused by the presence of gypsum, seen in the photo above, which results from attack by air pollution, originating from vehicular traffic and nearby local industry. 2) Delamination attributed to freeze-thaw cycling which occurs during the warming and cooling of the stone during winter days. When water enters the pores of the stone and freezes, the resulting expansion causes it to delaminate.

The conservation treatment study is focused primarily on finding a mitigation posed by the presence of gypsum on the surface and subsurface of the marble. Presently, the surface is held together by the growth of gypsum crystals.

One solution is to immobilize this soluble salt by turning it into an insoluble compound. This can be achieved by the use of barium hydroxide resulting in the formation of the extremely insoluble barium sulfate. On site treatment testing is underway to determine the effectiveness of this type of conservation treatment.

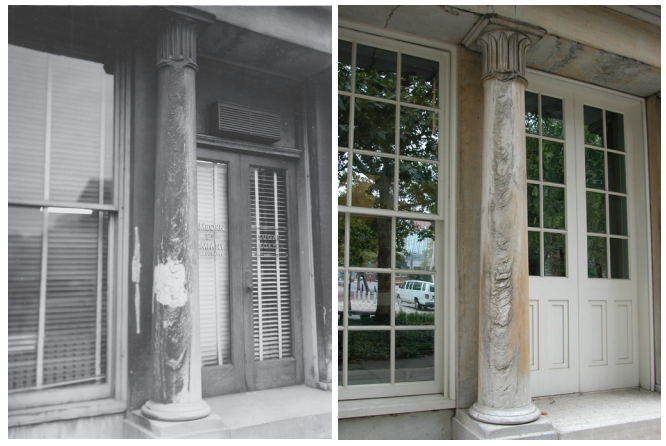
North Elevation, Column Nine February 19, 1957 and Summer 2004
Source: INHP Archives and University of Pennsylvania

The first floor columns were analyzed to understand the current conditions based on location, past treatments, and other recorded conditions. Due to available archival materials, an analysis was conducted to determine the stones' deterioration over time.

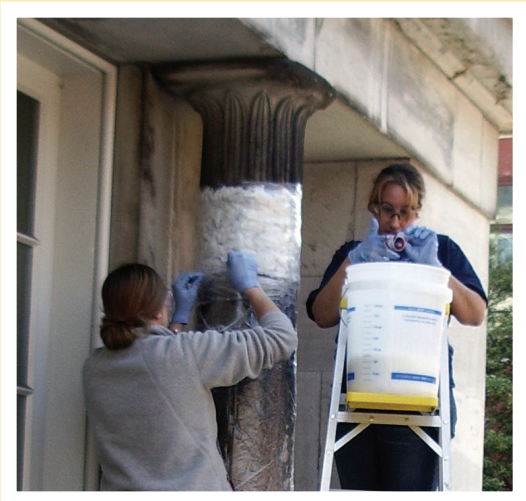
University of Pennsylvania students, Lyles McBratney and Jennifer Correia, applying the barium hydroxide treatment
Location: West Elevation, Column Four
